# Manhole Inspection Summary

Manhole # S29EE1020MH

Insp Date: **4/2/07 10:57 AM**

**Location** Address: **501 TUDOR ARMS**

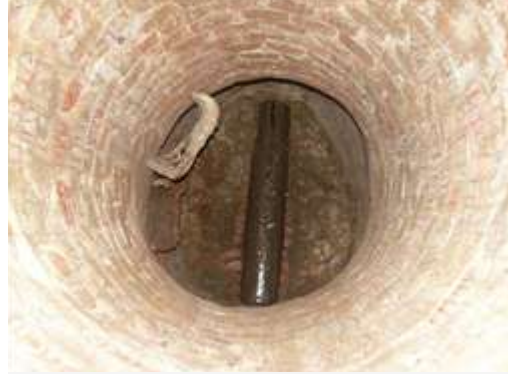
Top View

☐ Parged ☒ **Debris** (not Condition related)

**Steps** Count: **3** Missing: **0** ☒ **Corroded**

**Surcharge** ☒ **Evidence Of Surcharge** Depth: **2** (ft.) ☐ Active Surcharge Present

Corroded steps. Evidence of surcharge - Bench debris.

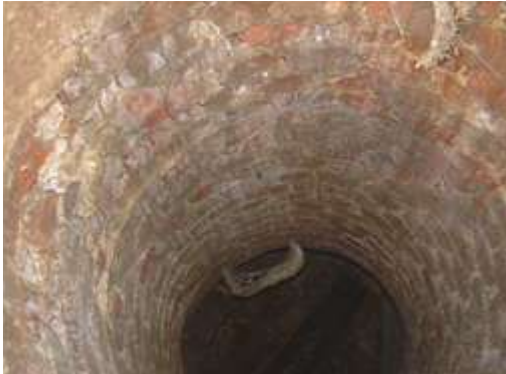
Defect

☒ **Leaks**

Condition: ☐ Sound ☐ Cracked ☐ Root Intrusion ☐ Loose Brick ☒ **Deteriorated**

Infiltration: ☐ None ☒ **Joint** ☐ Cracks ☐ Mortar ☐ Roots ☒ **Wall**

Frame leaks. Adjustment deterioration and infiltration.

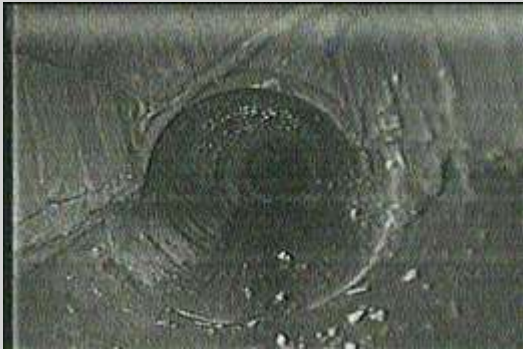
Pipe Out @ 12 O'Clock

Infiltration: **Evidence** Pipe Seal Cond: **Unknown**

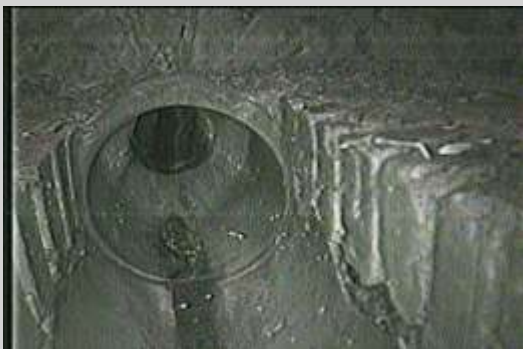
Pipe In @ 6 O'Clock

Infiltration: **Evidence** Pipe Seal Cond: **Cracked**
